Best practices for offline diagnosis of MV cables

H.T. Putter*, P. Legler* and A. Walker**

*H.T. Putter and P. Legler, Megger Germany

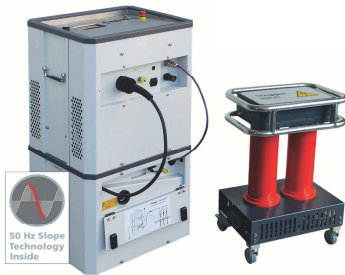
Fig. 2: Typical combined test and diagnostic module for cable testing, dielectric loss measurement and partial discharge diagnosis

For detecting global ageing of the insulation the PD diagnosis has limitations, for example moisture ingress cannot be detected. For detecting moisture ingress or water trees dielectric loss measurements are established. Therefore for aged cables always two diagnostics methods are recommended to asses the entire condition of the cable. To keep the number of test sets limited nowadays commercial equipment is available that merges the advantages of powerful commissioning testing and detailed non-destructive cable diagnosis an example is shown in Figure 2.

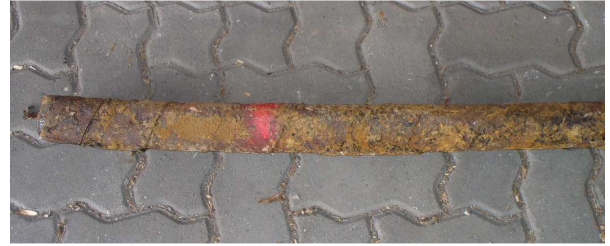
Fig. 12: Faulted cable segment, internal fault

Fig. 13 presents the PD mappings of the afterwards performed partial discharge measurements on phase L1 and L2 only. Results of the PD measurement with VLF 0.1 Hz Sin wave shape were compared with them of the VLF 0.1 Hz CR/ 50 Hz Slope diagnosis. Both wave shapes could localize PD signals with an inception voltage below the operation voltage. But only the PD measurement with the VLF 0.1 Hz CR test voltage detected and localized PD signals at 480 m. On this position later on, via subsequent cable fault location, the location of the breakdown has been confirmed. The fault was an internal fault and was not caused by any external damage. In Figure 12 a picture of the faulted segment is shown.

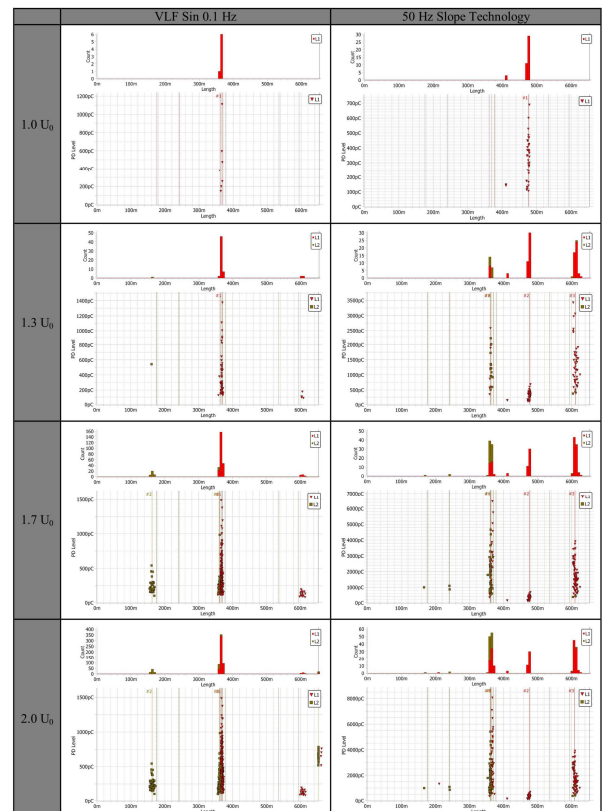
Fig. 13: PD mapping comparing VLF Sin and VLF CR

The PD detected and localized with VLF Sinusoidal test voltage was located on another position which with the PD measurement at VLF 0.1Hz CR only has been localized at a slightly higher test voltage.

Comparing the PD mappings at higher test voltage levels it can be seen that even at 2 U_0 it was not possible to detect and locate PD on the position of the breakdown using VLF 0.1 Hz Sin test voltage. In addition PD level and intensity are lower.

On the other hand the PD diagnosis using VLF 0.1 Hz Sin test voltage also located one weak spots where the PD intensity was higher compared to the 50 Hz Slope Technology. But a relevance so far cannot be drawn of those localized weak spots to the cable behavior at operation voltage.
