Diagnostic Test:

1-500Hz Narrow Band Dielectric Frequency Response

Case Study – EGAT – Thailand

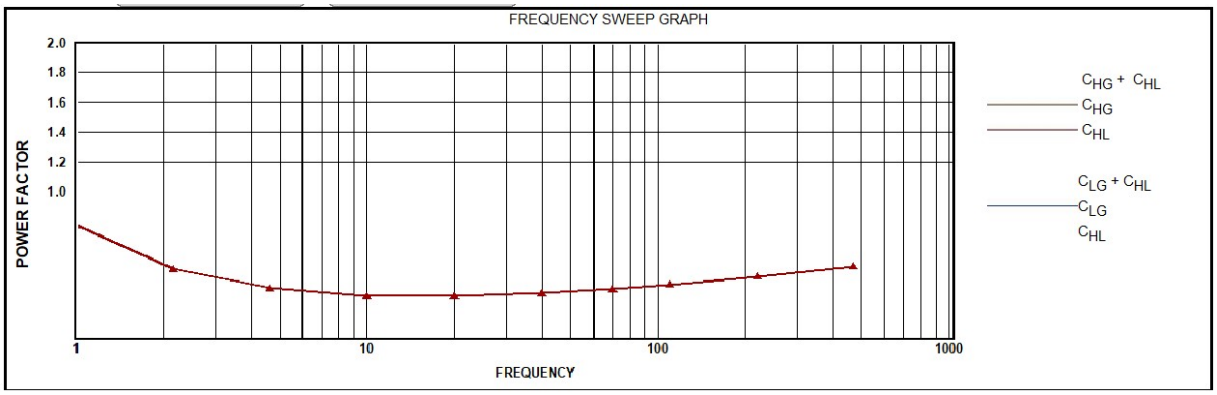
Figure 2 – Sample Narrow Band DFR | New Transformer | DELTA4000 | Scaled to max 2% PF

In the figure below, we see the typical shape for a new transformer, (Ch-I) where the curve is considered generally flat. The 60Hz result is 0.34%, the slope around line frequency is slightly positive and the maximum PF at 1 Hz is under 1%. We consider this insulation to be in excellent condition.

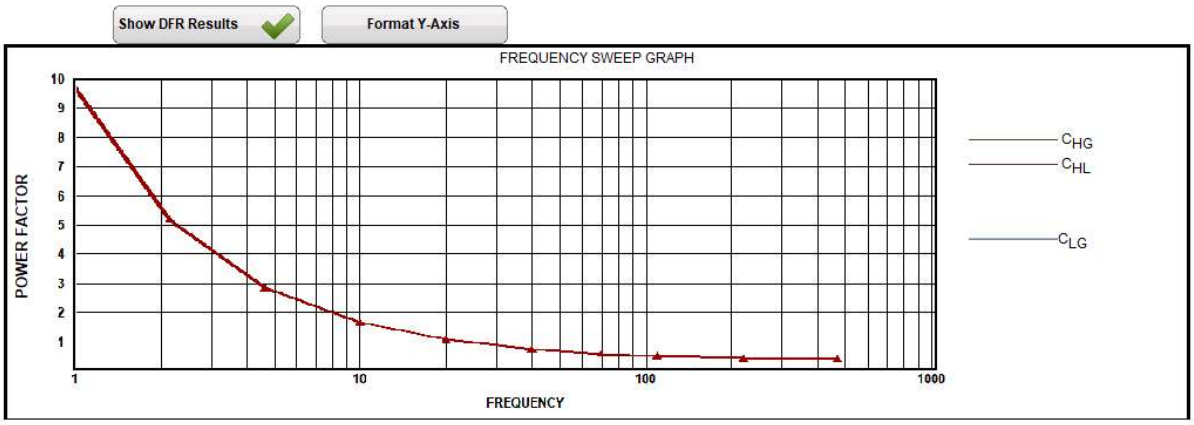
Figure 2 – EGAT – DELTA4000 | 1–500Hz 250V DFR Result | PF @ 50Hz – 0.52%

As an additional test to determine the condition of the paper + oil insulation, we were also able to conduct a narrow band DFR test (1-500Hz). Doing so added 7 minutes to the test time, but with no change in lead connections. The narrow band DFR provided us with the following result:

When observing figures 2 and 3, there is a significant difference in the curve shape even though the 60Hz PF (DF) are within only 0.18%PF of each other. One sees an upward curve in the EGAT transformer where the AEP example transformer shows a virtually flat response.

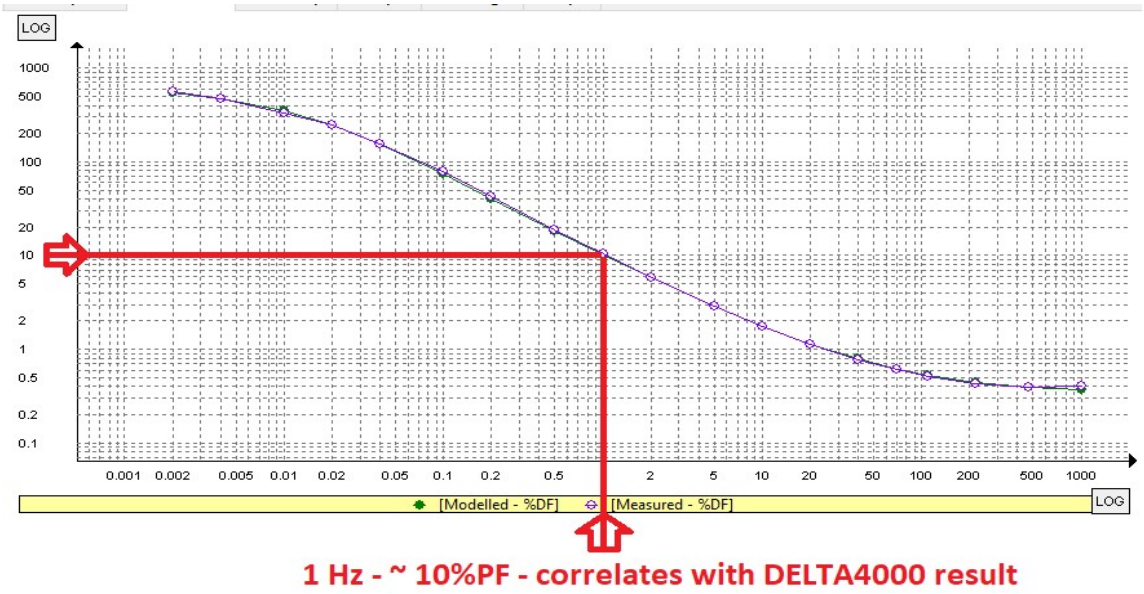
Figure 4 – EGAT – IDAX300 Curve | .002Hz – 1000Hz 200V DFR Result

The IDAX result for the EGAT transformer as shown below agrees with the DELTA4000 at 1 Hz, and so both tests are considered reliable and accurate.

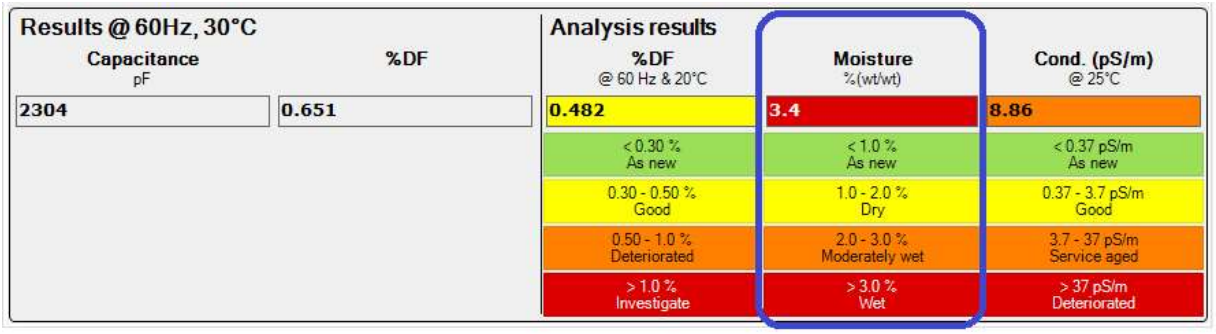
Figure 5 – EGAT – IDAX300 Analysis | 3.4% Moisture

IDAX300 with a wide band DFR test indicates that this transformer has a moisture issue in the paper insulation, which is not apparent in the 60Hz result. A content above 3% is considered WET, and this transformer has issues which are not apparent from the 60Hz PF result. If this transformer were to remain in service, this problem may get worse and result in a catastrophic failure, which is both a danger and a reliability concern. We also see that the oil conductivity is "service aged", and would require further mitigation efforts once the moisture issue was attended to.

The full DFR result concludes that the evidence of an issue from the narrow band DFR test is well founded. The additional test time of 7 minutes is considered excellent value, as no additional skill or equipment was needed.

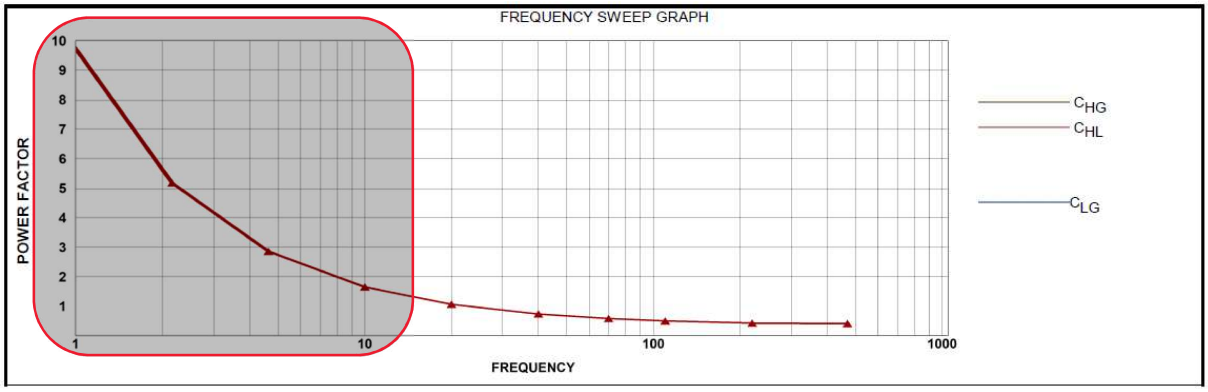
We consider the **1-500 Hz** ability of the DELTA4000 and the TRAX+TDX to be more sensitive to insulation issues versus our competitors because others only offer **15-500Hz** for their narrow band DFR. As shown below, one can see a significant upward curve of results across the 1-15Hz portion, whereas, with only 15-500Hz, this upward curve shape is not as apparent. The difference is observed on the example below versus competitor's unit:

Figure 6 - Greyed out area not visible in competitor's unit. Remaining graph portion appears almost flat.
